WASTE WATER TREATMENT PLANT AND INCINERATOR COMPLEX,
SITES 5EP2447 AND 5EP2446,
FORT CARSON, COLORADO

James Schneck
and
Karin M. Roberts

United States Department of the Interior
National Park Service
Midwest Archeological Center
Lincoln, Nebraska

September 1998

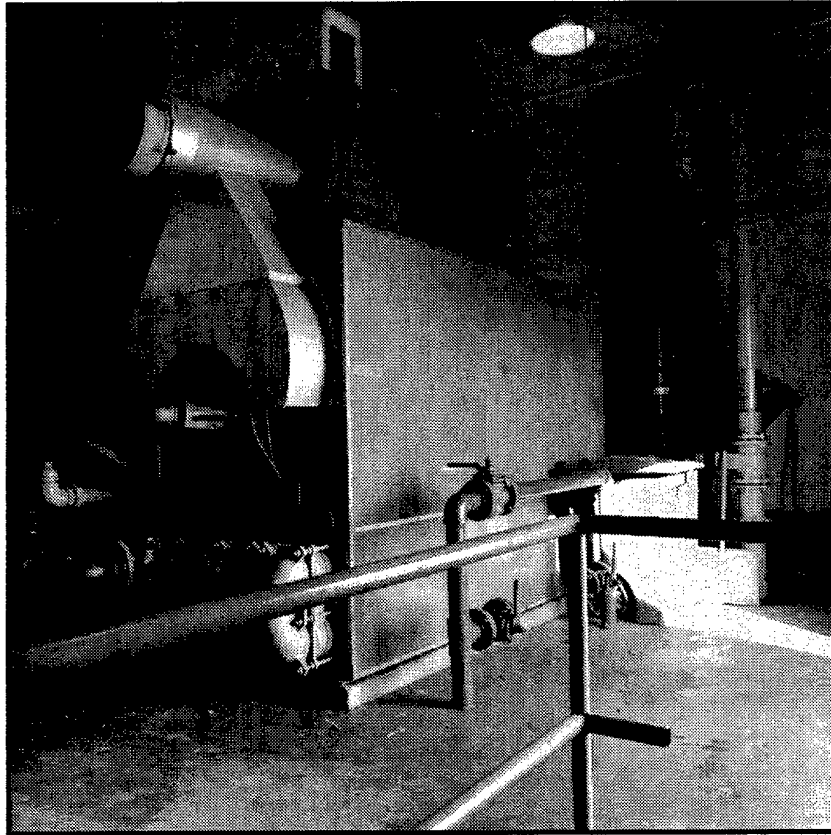
Figure II-36. Interior of Digester Control Room 3862. View of Digester's Modern Water Boiler. Roll HH14, Exposure 5.

Work at the Digester Control Room 3862 included the replacement of the hot water recirculation pump motor and impellers, mixing pump motors, heat exchanger, water boiler, and exhaust fan. The building's electrical wiring was also replaced.

During this time, extensive maintenance efforts were focused upon the digester complex. The roofing at Primary Digester 3860 was replaced and a replacement mixing pump was installed. Secondary Digester 3862 also received a replacement mixing pump and motor, as well as a replacement recirculation pump motor, impellers, and piping. Much of this equipment is located in Digester Control Room 3862. At about this time the Digester Control Room's hot water boiler was replaced.

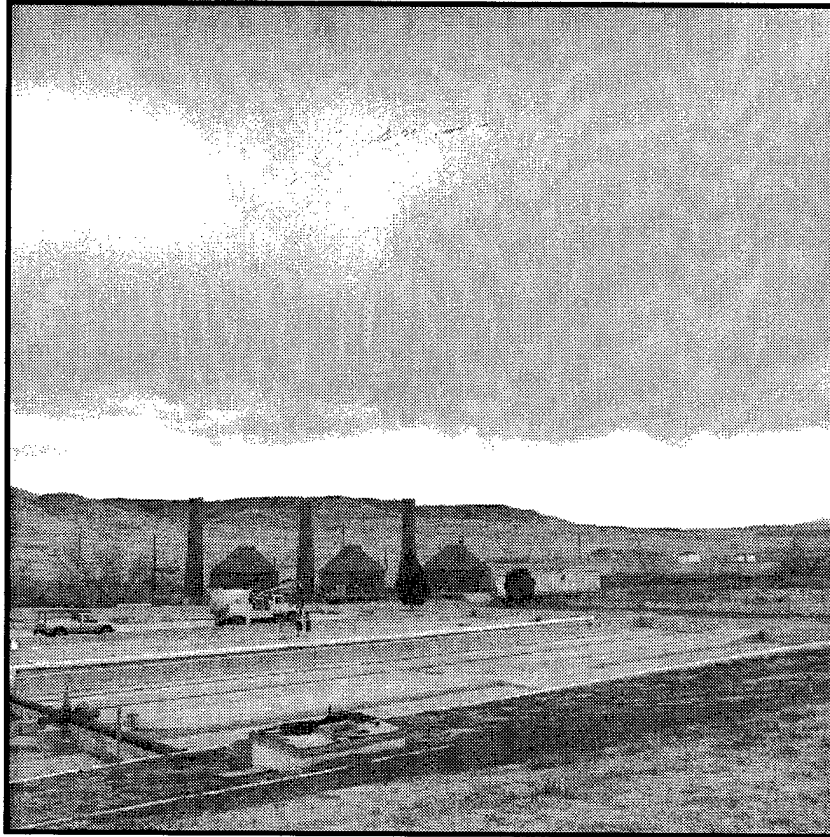
Figure II-39. View of West Half of Sludge Beds 3864, 3865, and 3866. View to the Southwest. Sludge Valve Pit in Foreground. Inlet Pipes to Left. Roll HH13, Exposure 2.

3864- Sludge Bed	1942	1961 1984	Modifications in 1961 consisted of the replacement of piping, inlet boxes, bed sectionalizing, replacement of sand, and repair of existing support structure. Concrete ramps, bed dividers and inlet sluice gates were constructed in 1984, replacing the original sand and gravel floors. This allowed the bed to be compartmentalized into four separate beds rather than the previous two. Also in 1984 was the installation of push-on joints to PVC piping.
3865- Sludge Bed	1942	1961 1984	Modifications in 1961 consisted of the replacement of piping, inlet boxes, bed sectionalizing, replacement of sand, and repair of existing support structure. Concrete ramps, bed dividers and inlet sluice gates were constructed in 1984, replacing the original sand and gravel floors. This allowed the bed to be compartmentalized into four separate beds rather than the previous two. Also in 1984 was the installation of push-on joints to PVC piping.

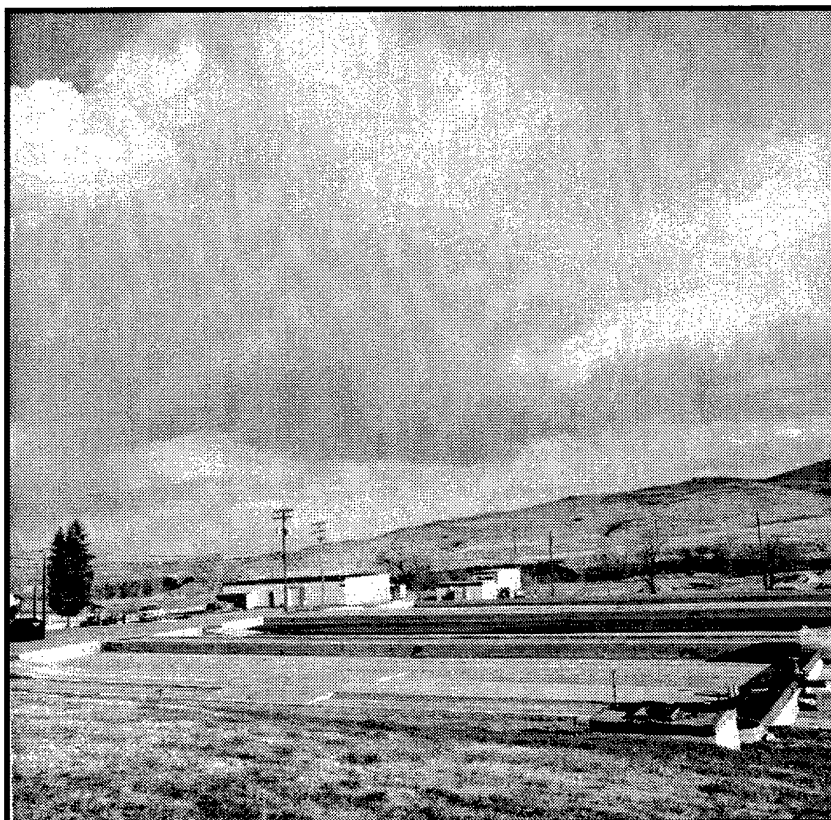
Figure II-40. View of East Half of Sludge Beds 3864, 3865, and 3866. Looking Southeast. Sludge Valve in Foreground, Inlet Pipes to Right. Roll HH13, Exposure 4.

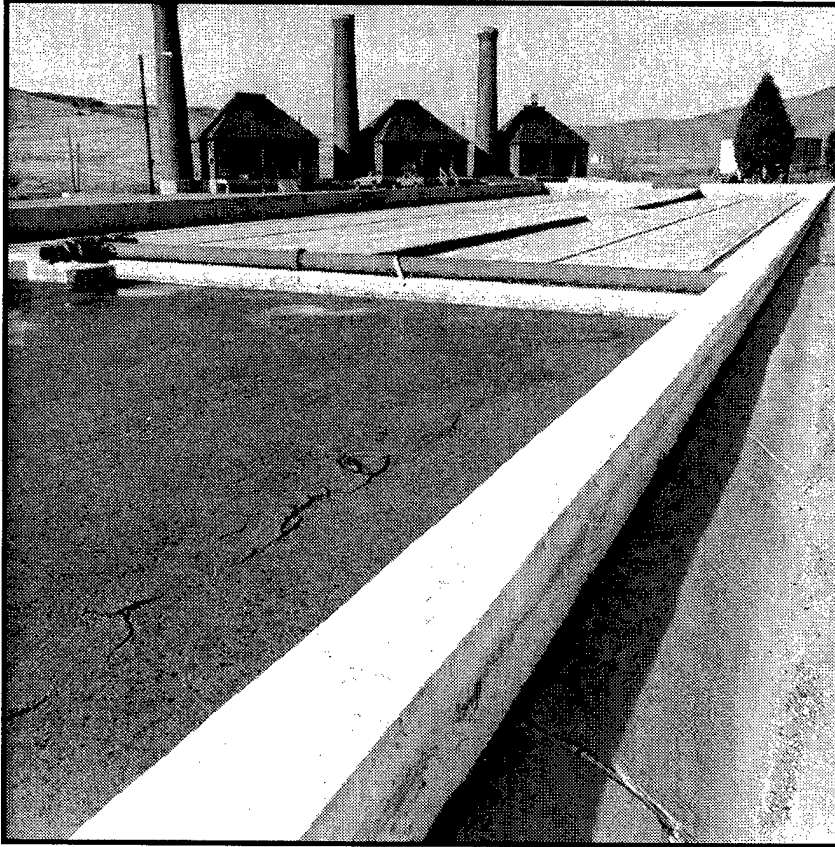
Figure II-41. View of Typical Sludge Drying Operation at Sludge Bed 3866. Note Concrete Floor and Drainage Cuts in Far, Empty Half. Fill Pipe Separates Halves. Roll HH14, Exposure 9.

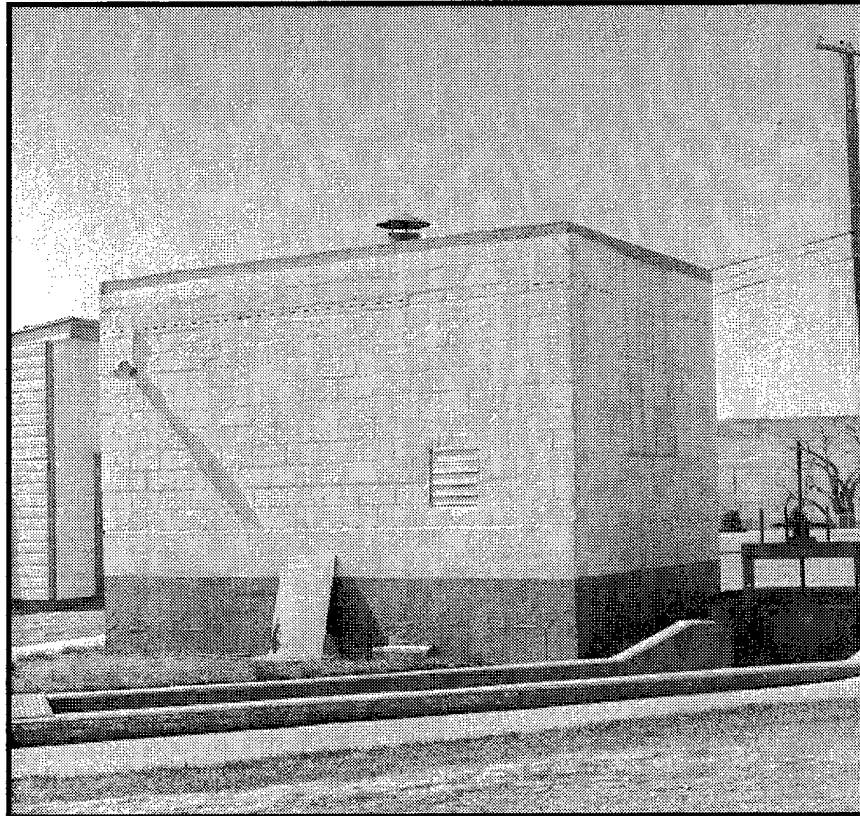
Figure II-42. 3/4 View of Northeast and Northwest Faces of Screen House 3870. Bypass Channel to Right in Foreground and Standby Generator Building 3873 in Background. Roll HH7, Exposure 10.

The WWTP Screen House 3870 was rebuilt in 1957. The original wood frame walls and gable roof were replaced with concrete block walls and a flat, poured concrete roof. The new walls were constructed over the original foundation. One course of blocks near the roof line was laid sideways and provided ventilation. Original double-hung wood-frame windows were replaced with metal sash-type windows.

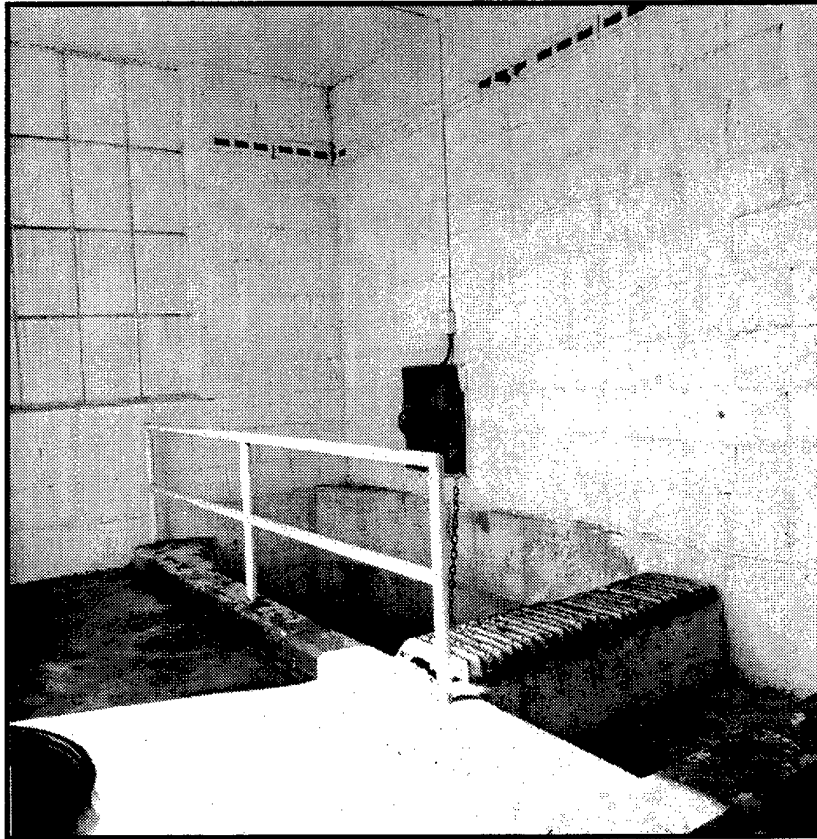
Figure II-44. Interior View of Screen House 3870. Screen and Screen Pit in Corner. Roll HH11, Exposure 4.

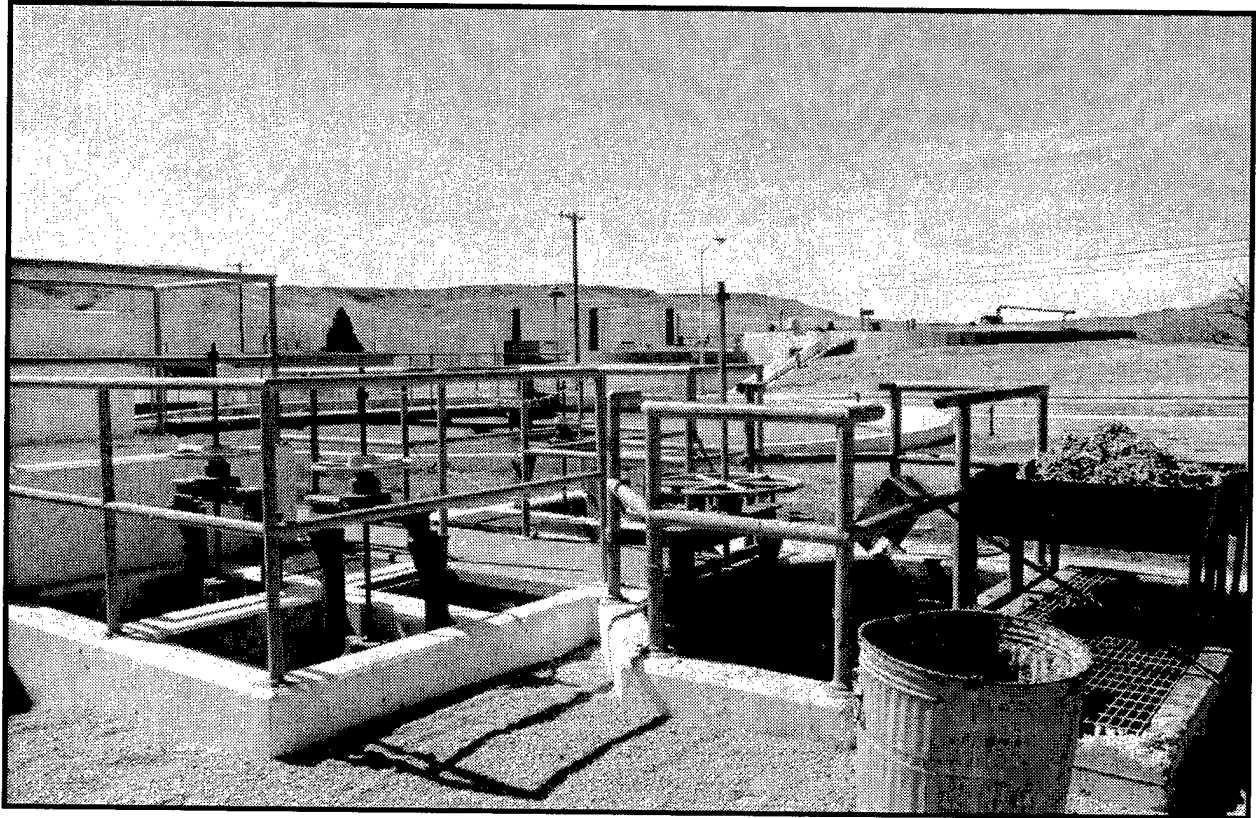
Figure II-45. View of Diversion Box 3875 Looking Southwest. Original Six-Sided Box to Right. Roll MWAC1, Exposure 13.

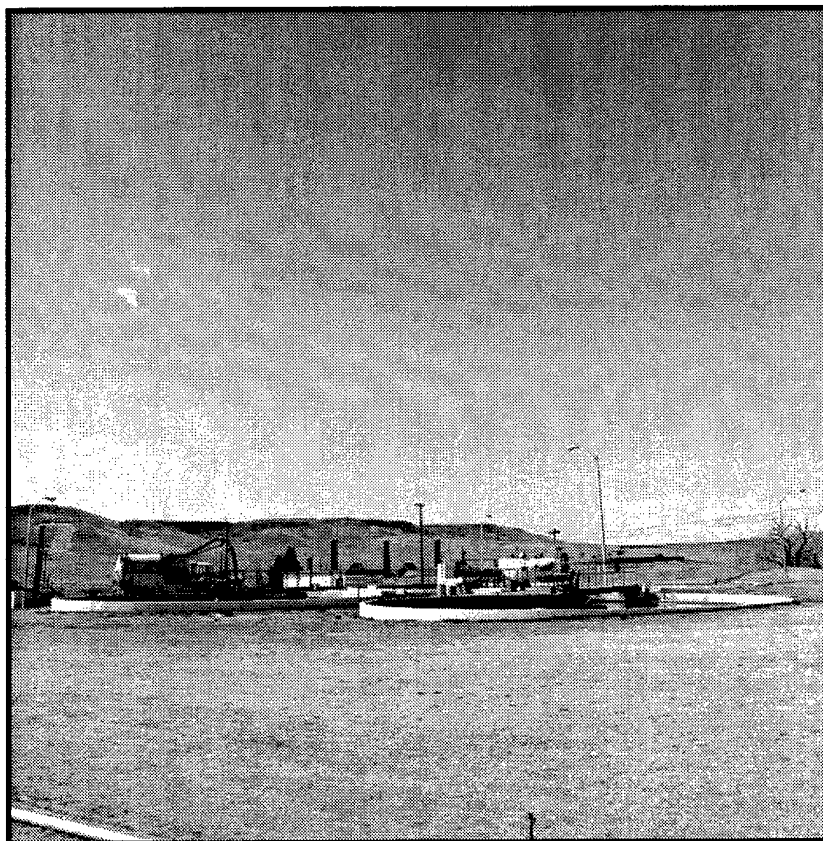
Figure II-46. View of Primary Clarifiers 3876, 3877, and 3879 to the South.
Roll HH24, Exposure 7.

Modifications included replacing the mechanical equipment at Primary Clarifiers 3876, 3877, and 3879 and Secondary Clarifiers 3888, 3892, and 3895. Replacements included the center

columns, rake arms, and blades of the sweeps. Cracked concrete floors were repaired and regrouted where needed.

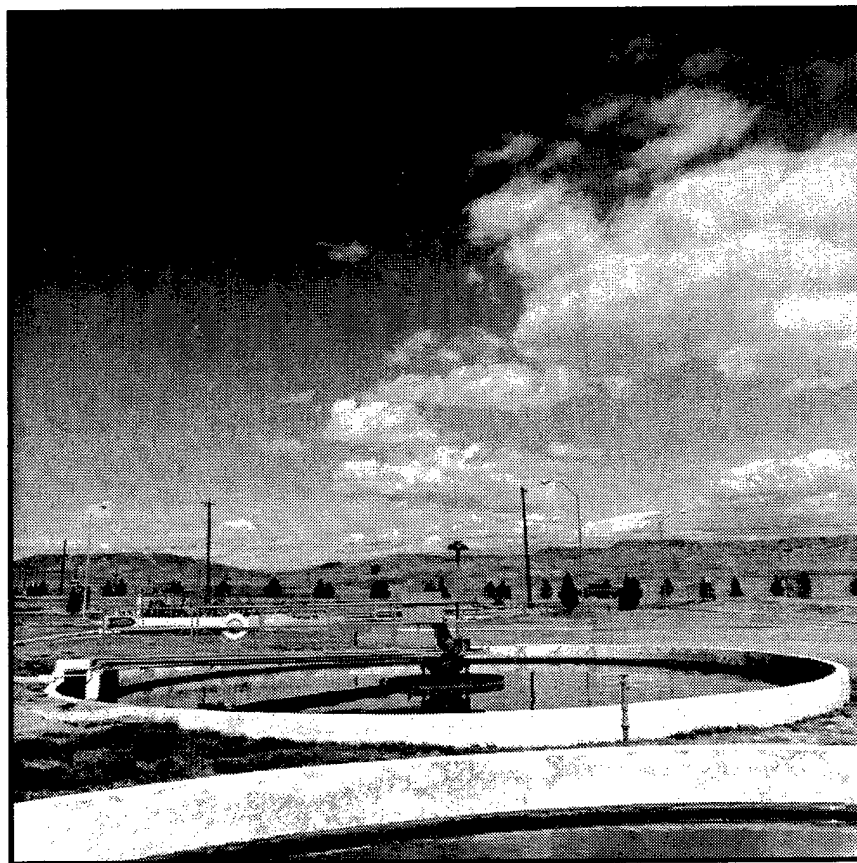
Figure II-48. View of Typical Primary Clarifier Mechanism at Primary Clarifier 3876. Walkway Provides Access Mechanism Motor. View from Clarifier 3886. Roll HH25, Exposure 9.

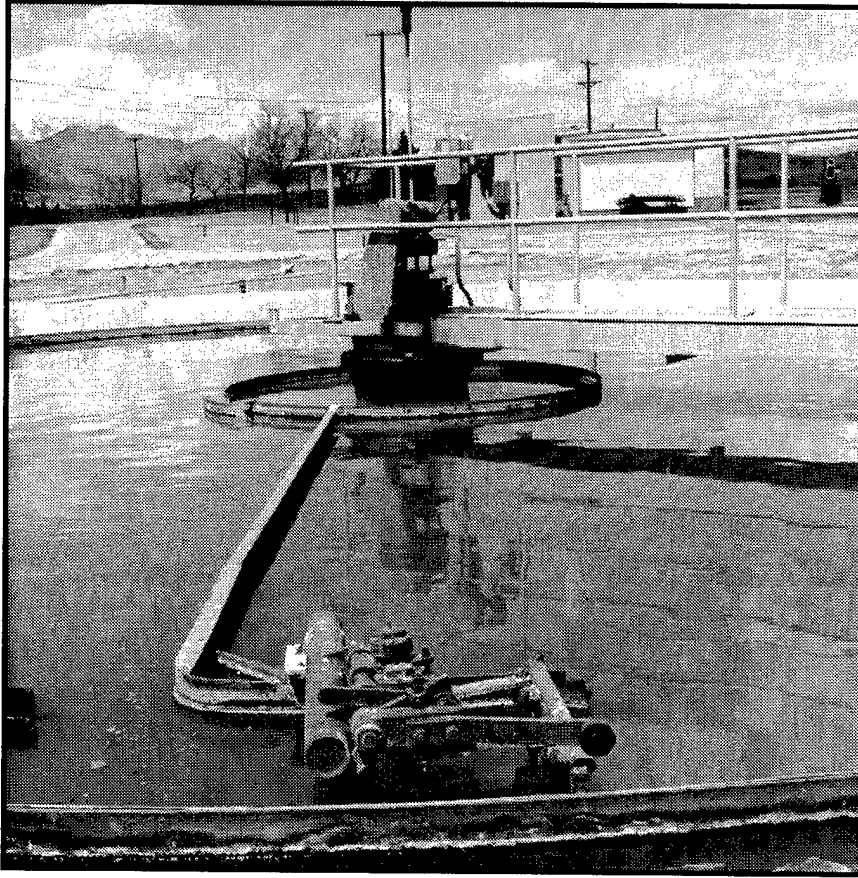
Figure II-49. Detail View of Typical Primary Clarifier Skimmer at Primary Clarifier 3877. Roll HH26, Exposure 2.

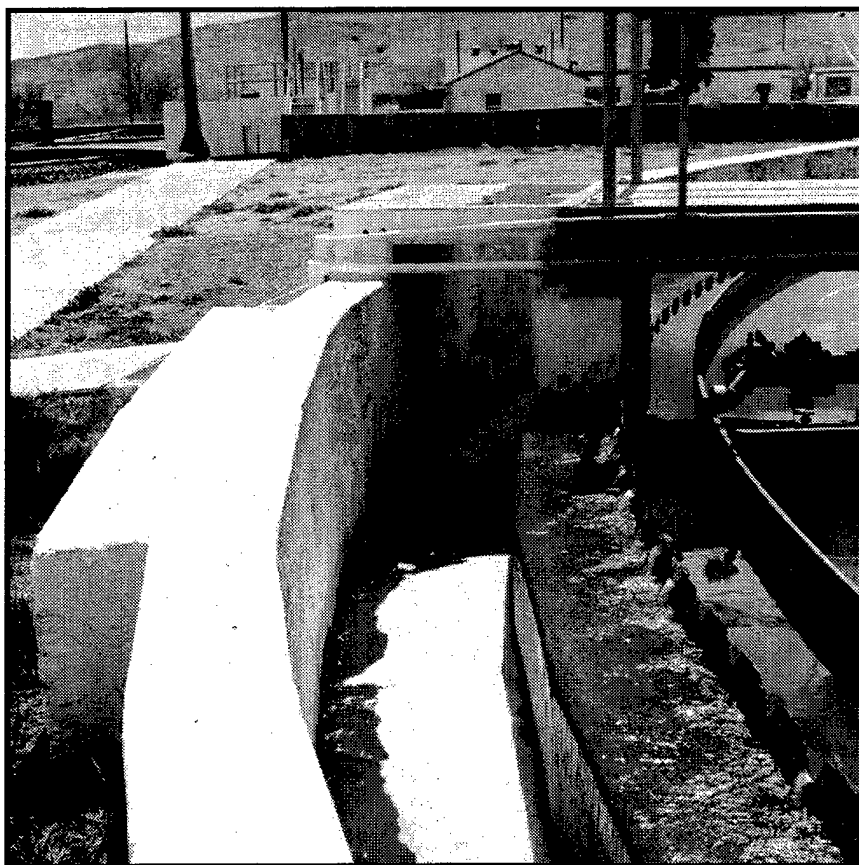
Figure II-50. Detail View of Typical Primary Clarifier Effluent Drain, Weir Plate, Skimmer Rail, and Skimmer Mechanism. View from Primary Clarifier 3877. Roll HH26, Exposure 11.

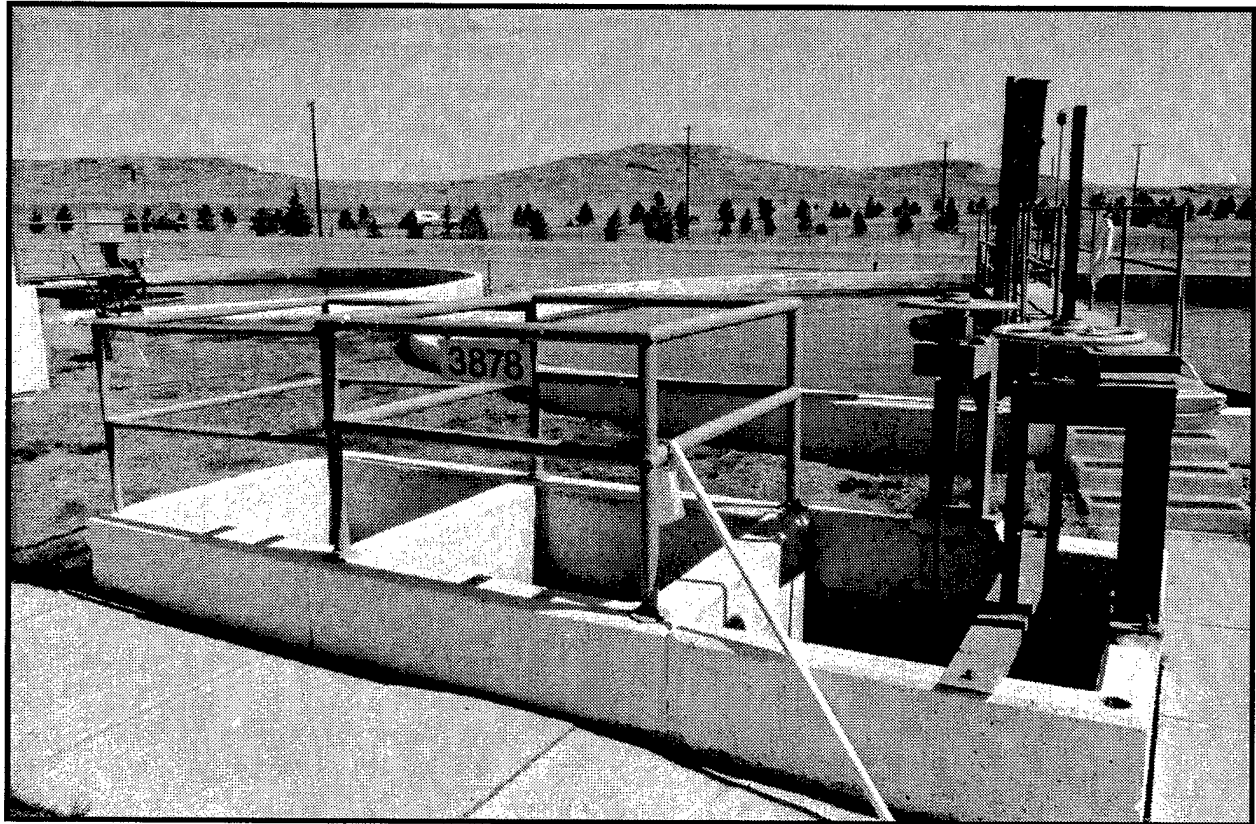
Figure II-51. View of Diversion Box 3878 to the North. Original Construction at Center Flanked by Modifications on Both Sides. Roll MWAC1, Exposure 15.

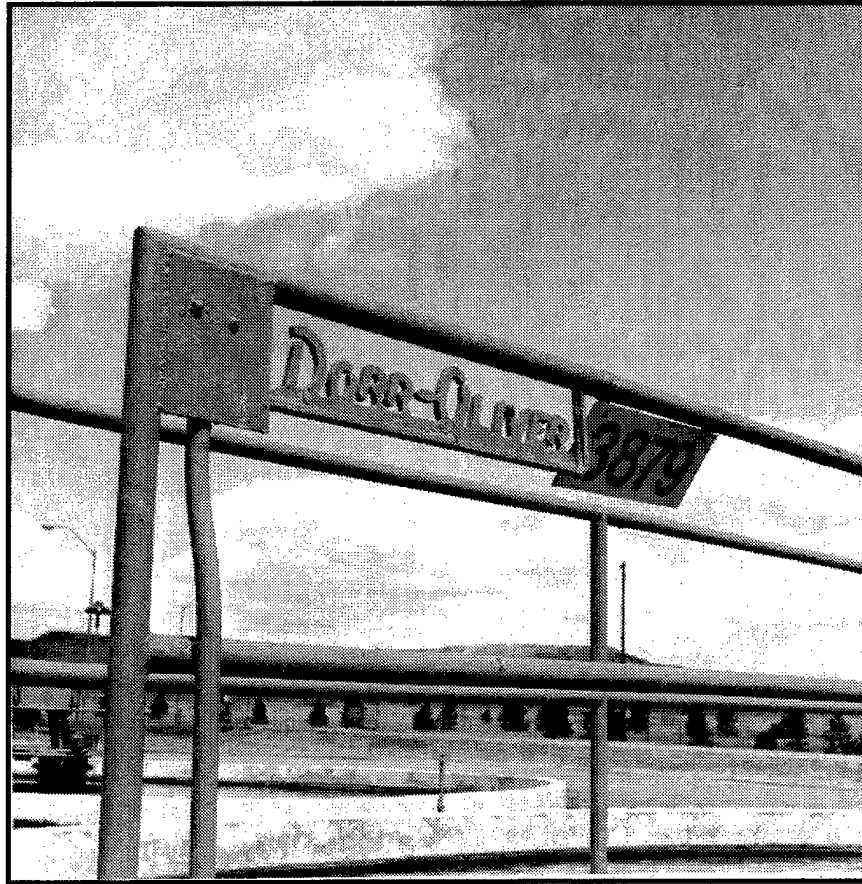
Figure II-52. Detail view of Typical Walkway Nameplate for a Primary Clarifier. Dorr-Oliver Produces Much of WWTP Mechanical Equipment. View of Primary Clarifier 3879. Roll HH26, Exposure 5.

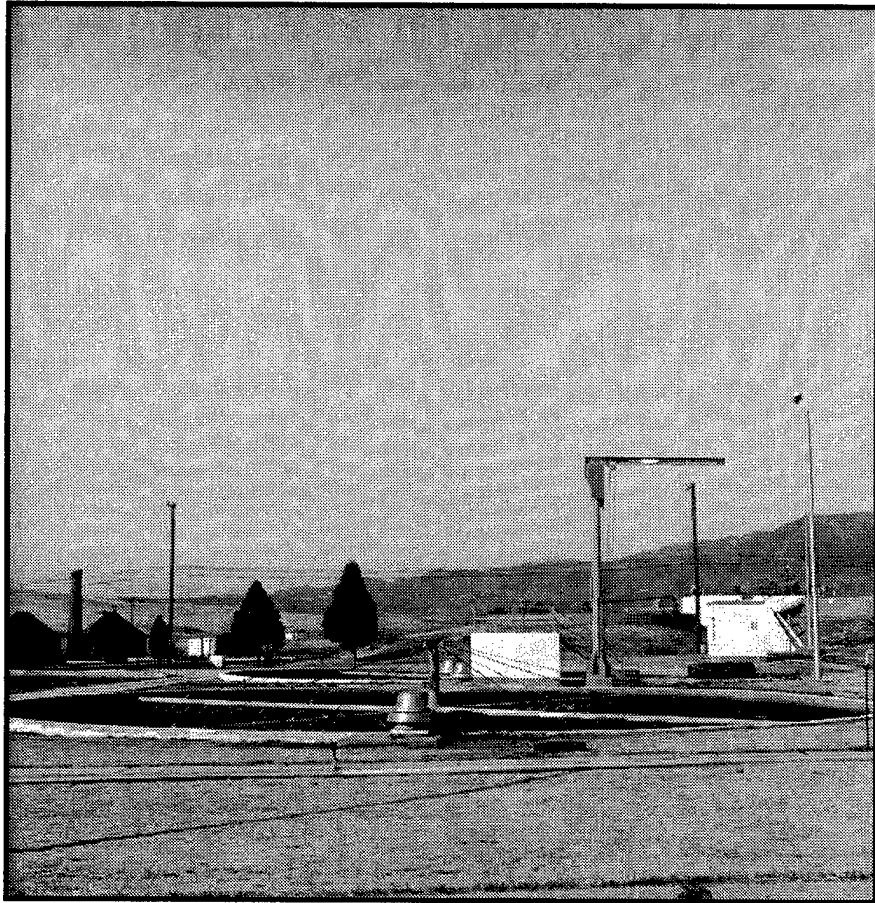
Figure II-53. View of Trickling Filter 3881 Looking Southwest. Rotating Distributor Booms Distribute Waste Water Through Zoogly Mass. Metal Ventilators Aerate Mass. Lawn Irrigation Pipes in Foreground. Roll HH15, Exposure 2.

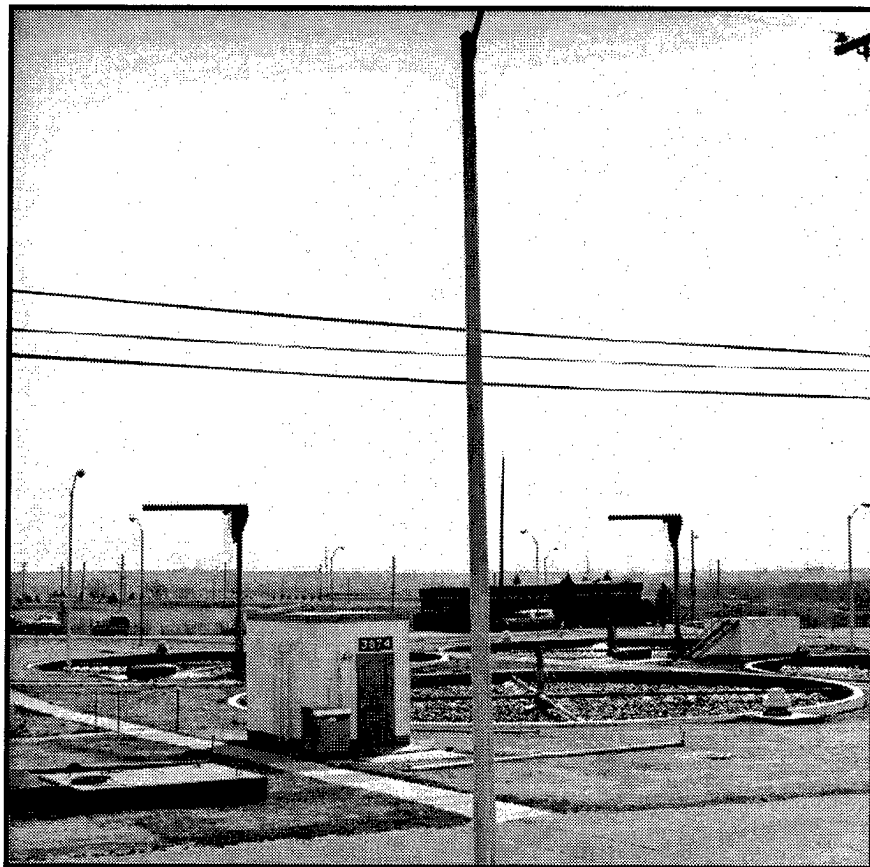
Figure II-54. General View of Trickling Filters 3881, 3883, 3884, and 3886 to the Southeast. Note Filter Head Box 3885 and Cranes. Electrical Power Building 3874 in Foreground. Roll HH15, Exposure 7.

The plant underwent a minor upgrade in 1984 and 1985. New steel swinging filter head box cranes constructed in 1984 at Filter Head Boxes 3882 and 3885 facilitated removal of large metal filter screens. Secondary sludge and recirculating pumps and motors, flow meters, and a manual set point controller at Laboratory and Control 3887 were replaced. Concrete ramps, bed dividers, and inlet sluice gates were constructed at Sludge Beds 3864 and 3865. These improvements replaced the original sand and gravel floors, and allowed each bed to be compartmentalized into four separate beds rather than the previous two. At this time Sludge Bed 3866 was constructed immediately south of 3865. It was constructed with a concrete floor similar in design to the new floors of the existing sludge beds. The small portion of Sludge Holding Tank 3861 that sat above grade was buried in 1992. This tank was removed in 1994.

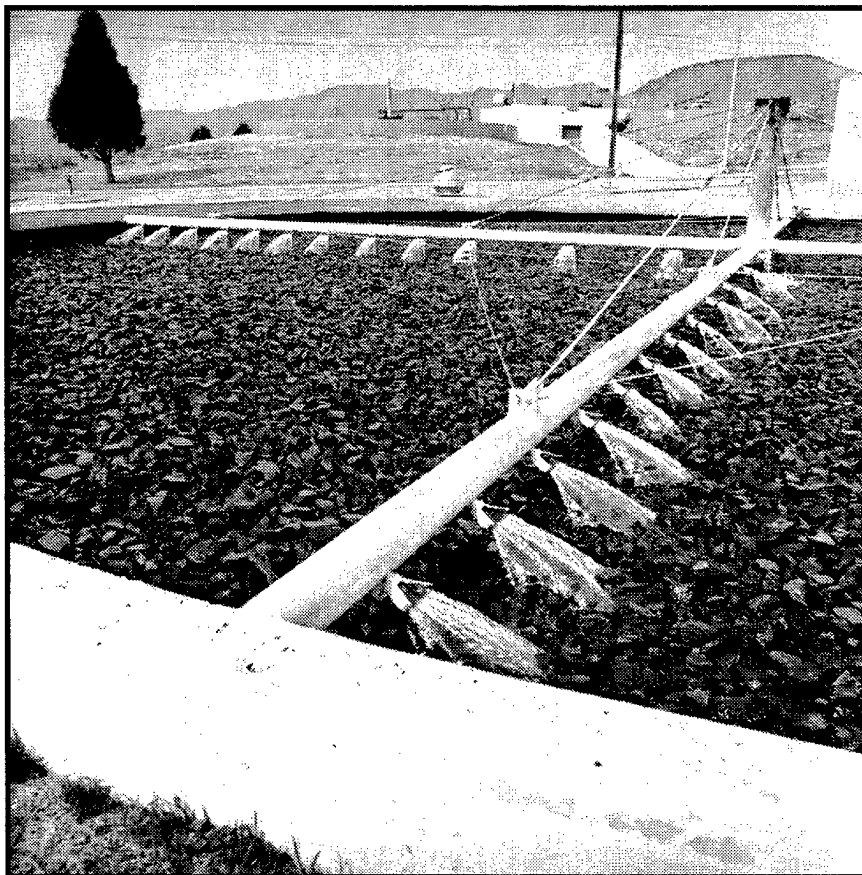
Figure II-55. Detail View of 1981-era Distributor Boom at Trickling Filter 3881.
Roll HH16, Exposure 6.

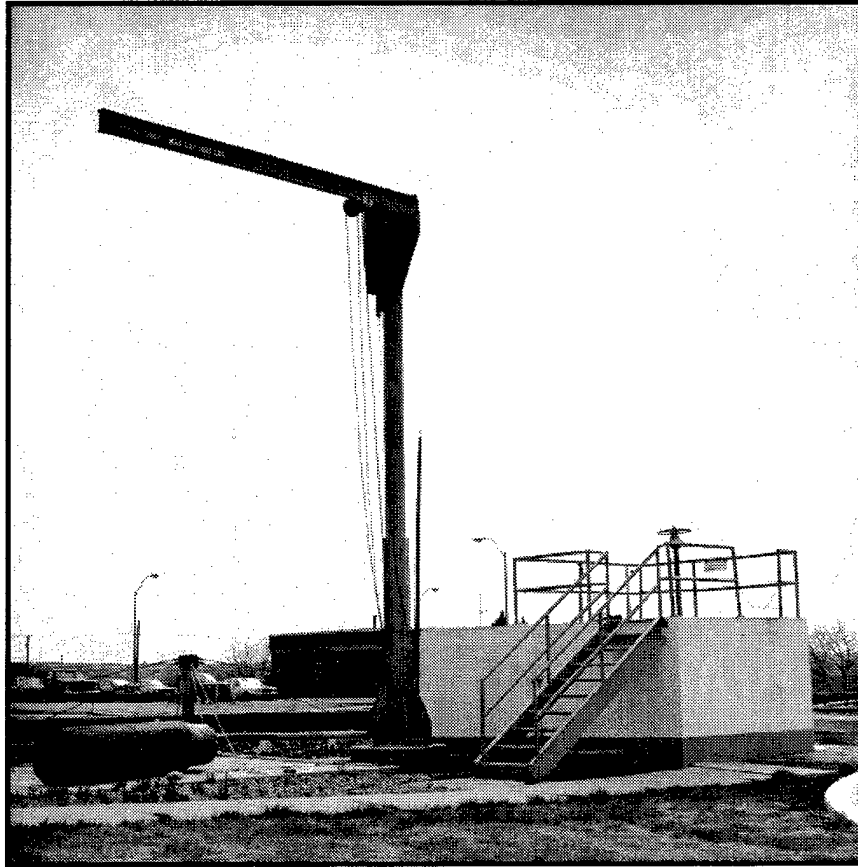
Figure II-56. 3/4 View of Filter Head Box 3882 to the East. Note 1980s-era Filter Head Box Crane. Roll HH16, Exposure 11.

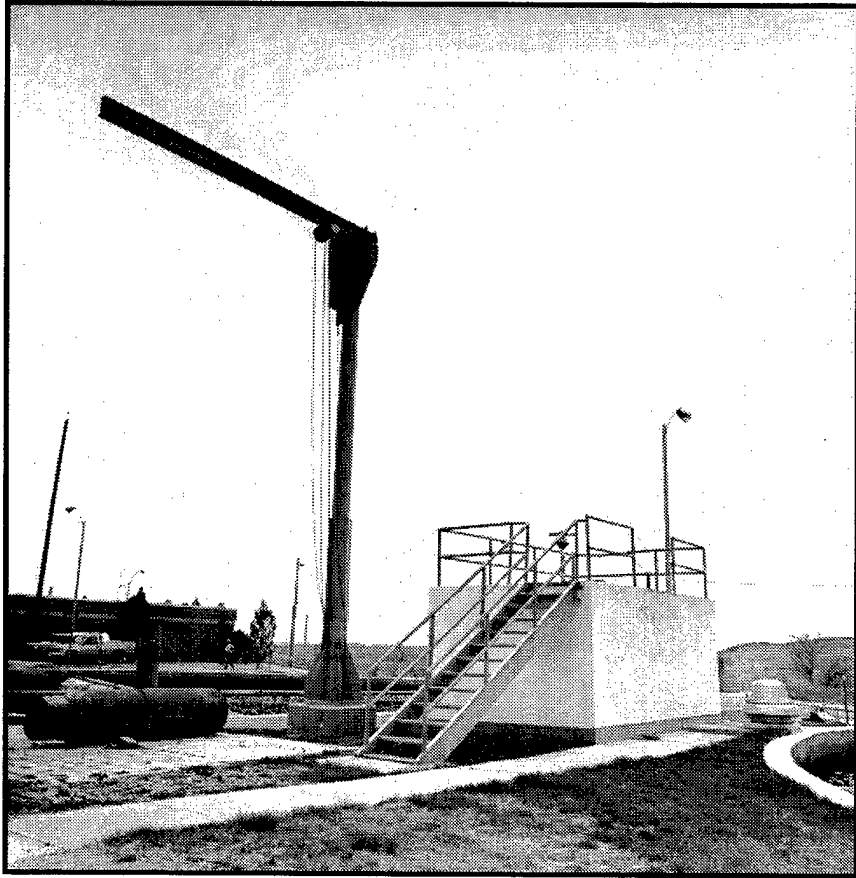
Figure II-57. 3/4 View of Filter Head Box 3885 to the South. Note 1980s-era Filter Head Box Crane. Roll HH18, Exposure 5.

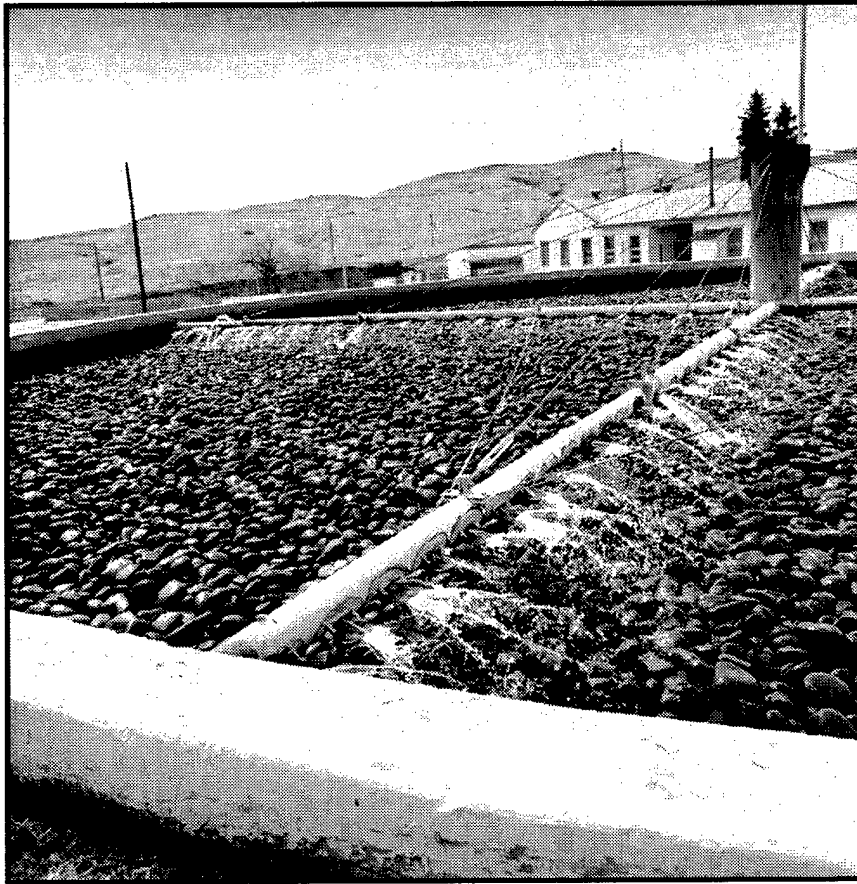
Figure II-58. Detail View of 1980s-era Distributor Boom at Trickling Filter 3886. Distributor Boom Mechanism Typical for Filters 3883, 3884, and 3886. Roll HH18, Exposure 2.

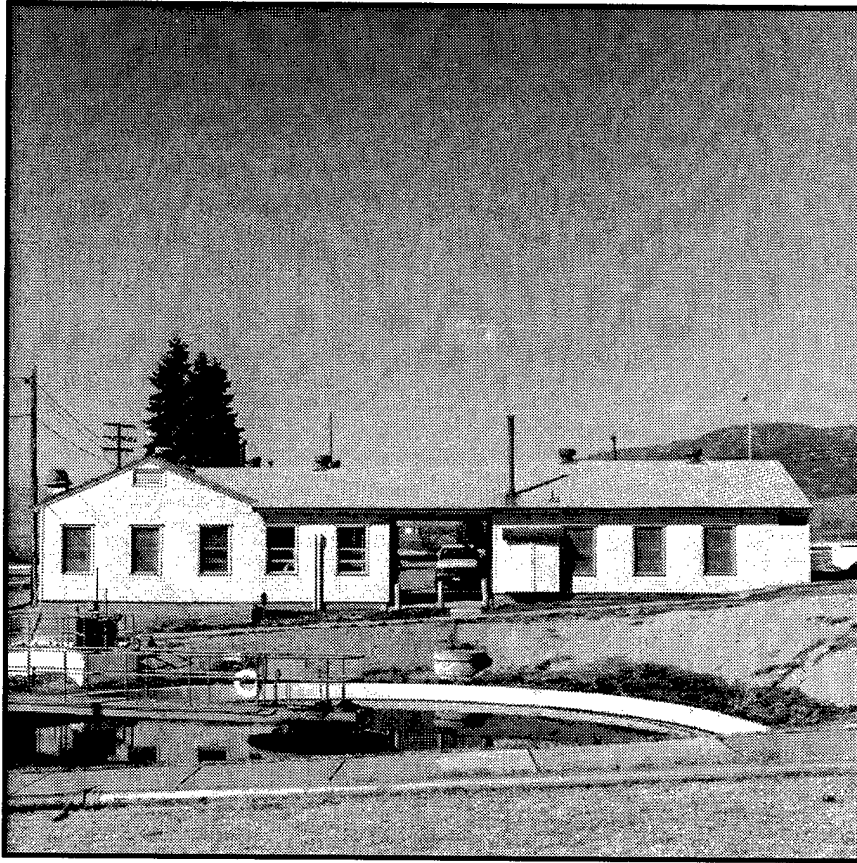
Figure II-59. View of East Face of Laboratory and Control 3887. Covered Drive-through Divides North and South Wings. Secondary Clarifier 3888 in Foreground. Roll HH6, Exposure 6.

Laboratory and Control 3887, referred to in the 1942 completion report as the Chlorinator Laboratory Building, was extensively remodeled as part of the overhaul. Electrical wiring and entrance doors were replaced in the building's north wing. This wing was originally a large room used for storage of chlorine tanks. In 1961 the northwest corner of the room was partitioned off with concrete block walls. Into this new room was moved all chlorinator equipment, including chlorine tanks, regulators, and a scale. The remainder of the north wing's space was used to house a new waste flow foam suppression system and general storage areas. Building 3887's laboratory room on the first floor of the south wing was remodeled with the installation of new wainscoting, insulation, drywall, ceiling tiles, asphalt floor, and cabinets. Recirculation equipment including pumps, valves, and fittings housed in the lower level of the south wing, was replaced. The portion of the first floor of the south wing that formerly housed the chlorinator equipment was converted to a motor control room, housing control panels that allowed remote monitoring and operation of the plant's mechanical equipment. Filter exhaust fans were replaced and existing light fixtures were removed and replaced with shallow dome reflectors. Exposed conduits were removed or hidden. Room heaters and a new ventilation system were installed in the basement beneath the south wing. One of the building's recirculation pumps was replaced and piping for a new irrigation system was installed. The building exterior was also modified. A concrete retaining wall, likely the present one that surrounds the building's north side, was constructed. It was probably at this time that original wood double-hung windows were replaced with the present combination aluminum windows.

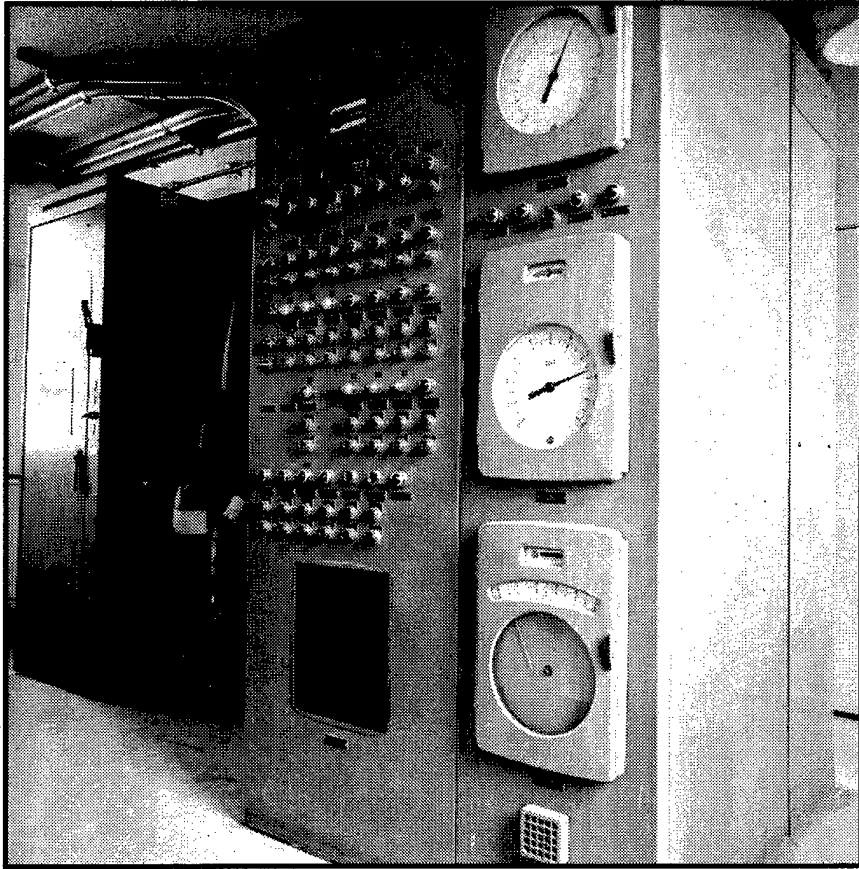
Figure II-62. Interior View of Laboratory and Control 3887. View of Control Panel on Main Floor, South Wing. Roll HH27, Exposure 3.

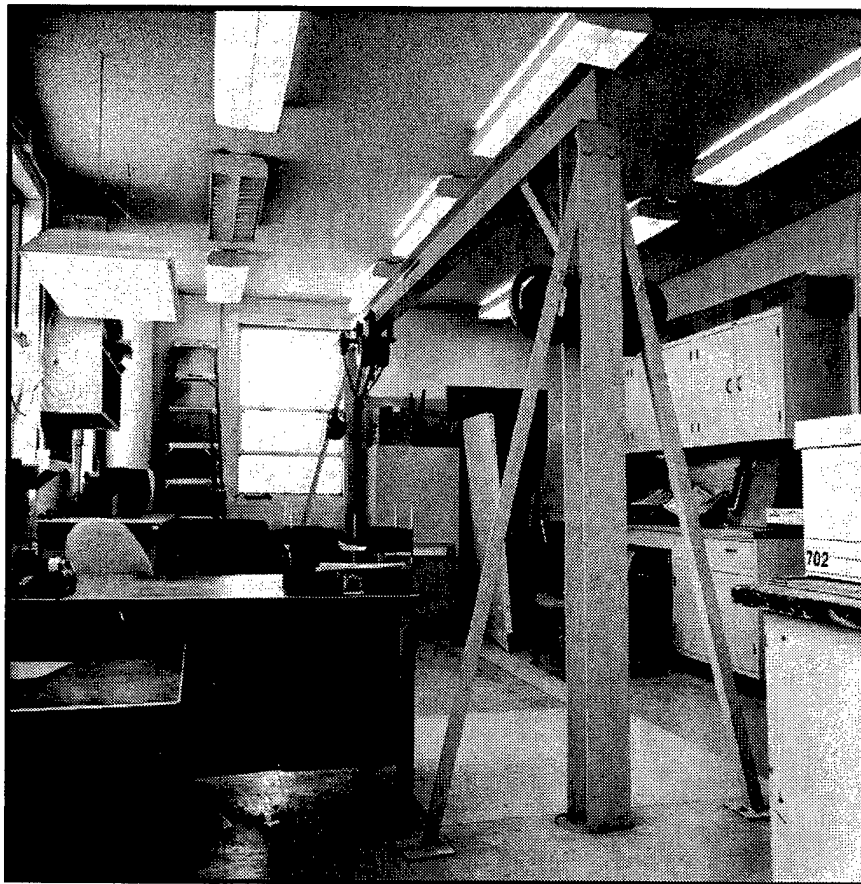
Figure II-63. Interior View of Laboratory and Control 3887. View of Original Laboratory Room on Main Floor of South Wing. Floor Beneath Modern Crane Opens to Left Secondary Sludge and Recirculation Pump from Basement. Roll HH27, Exposure 5.

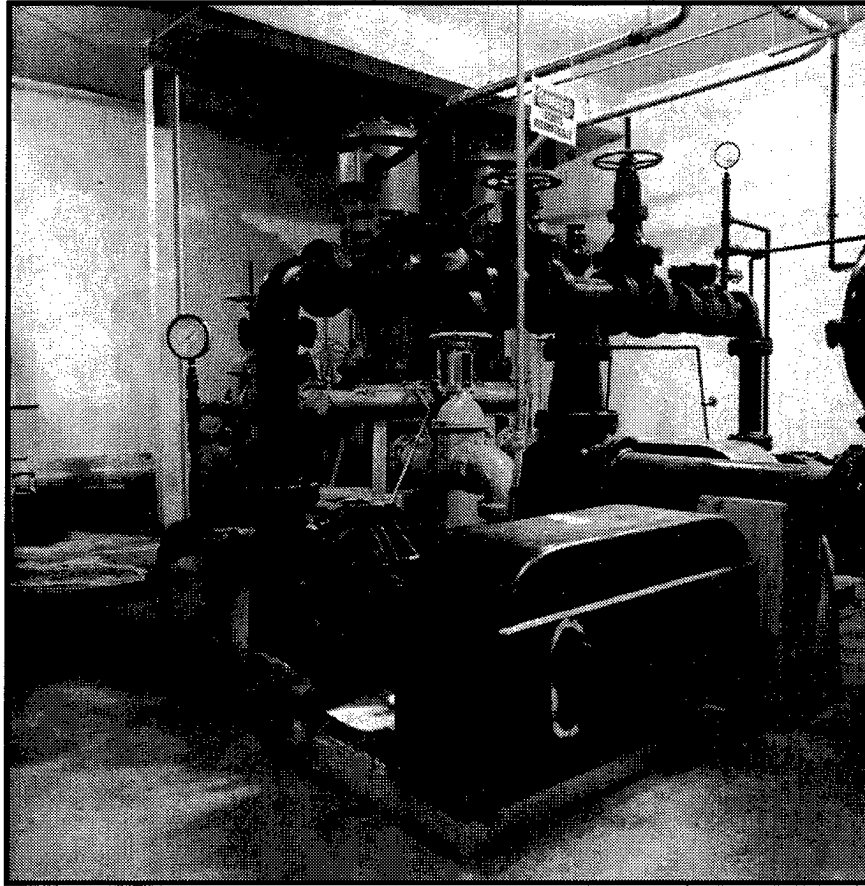
Figure II-64. Interior View of Laboratory and Control 3887. View From Basement in South Wing of Secondary Sludge and Recirculation Pumps. Roll HH27, Exposure 6.

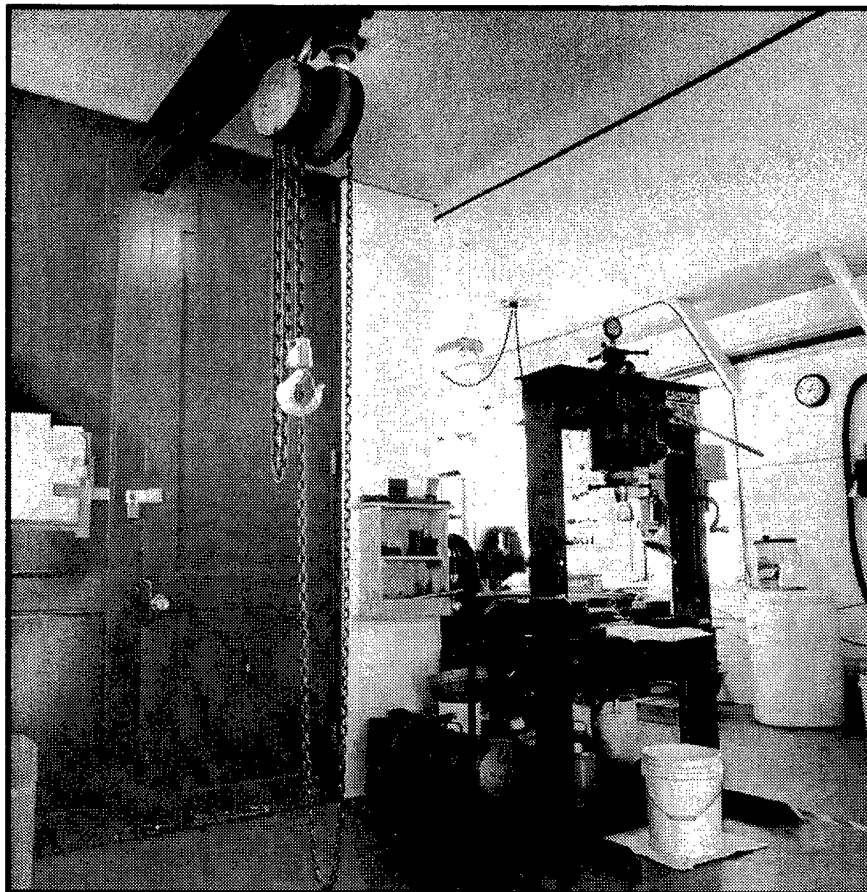
Figure II-65. Interior view of Laboratory and Control 3887. Original Chlorine Storage Room on Main Floor of North Wing (Now Storage Area and Shop). Room to Left is 1961-era Modification. Overhead Traveling Crane Moved Chlorine Tanks. Roll HH27, Exposure 10.

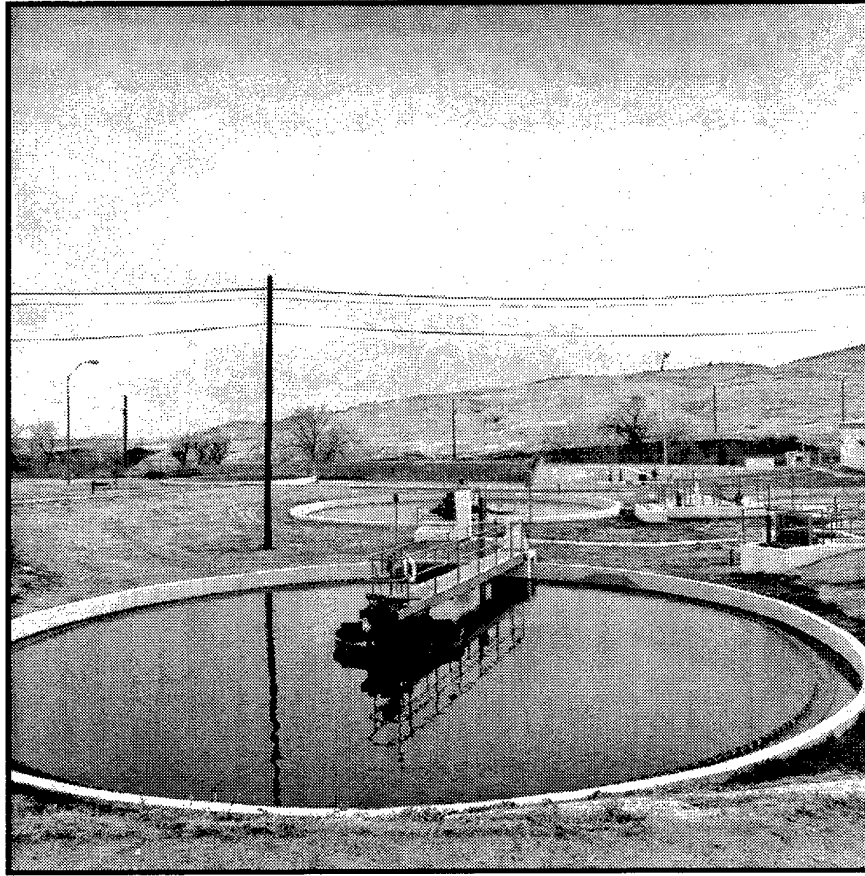
Figure II-66. View of Secondary Clarifier 3888 to the Southeast. Diversion Box 3890 to right in Background. Roll HH19, Exposure 4.

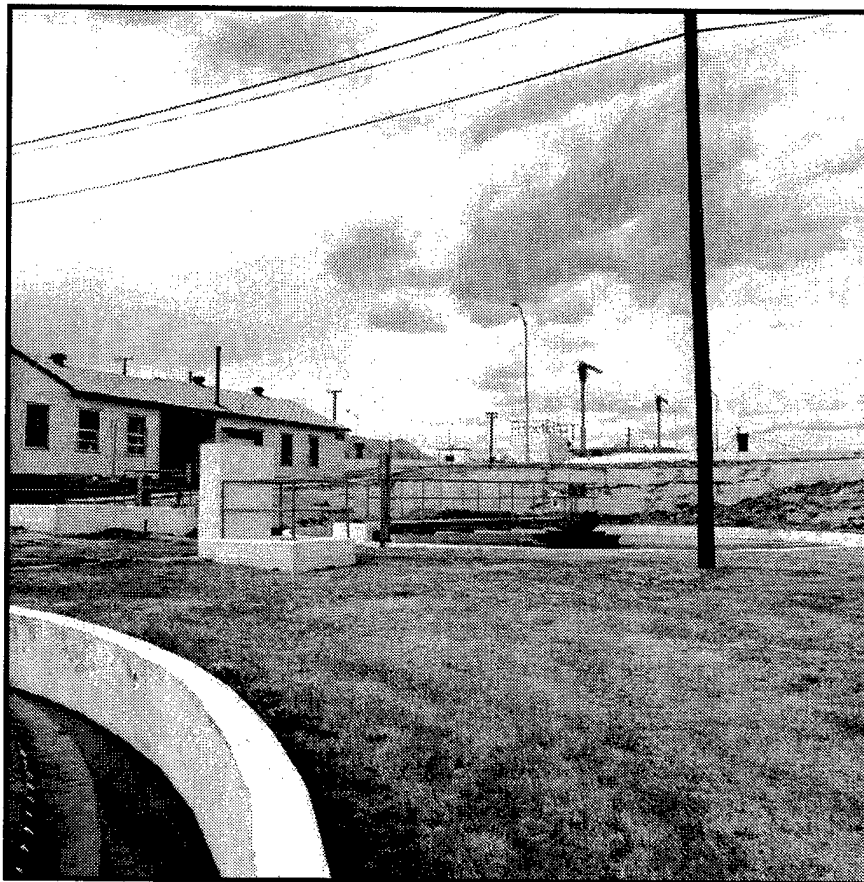
Figure II-67. View of Unnamed Abandoned Flow Box. This Open Structure Sits Over the Exposed Channel Carrying Effluent From Secondary Clarifier 3888 to Diversion Box 3891. Roll HH19, Exposure 8.
